# Reserve Study

## West Park Community Association

Section 25, Kings Park West  
Fairfax County, Virginia, USA

For Period Beginning:	January 1, 2017
Ending:	December 31, 2017
Date Prepared:	September 3, 2016

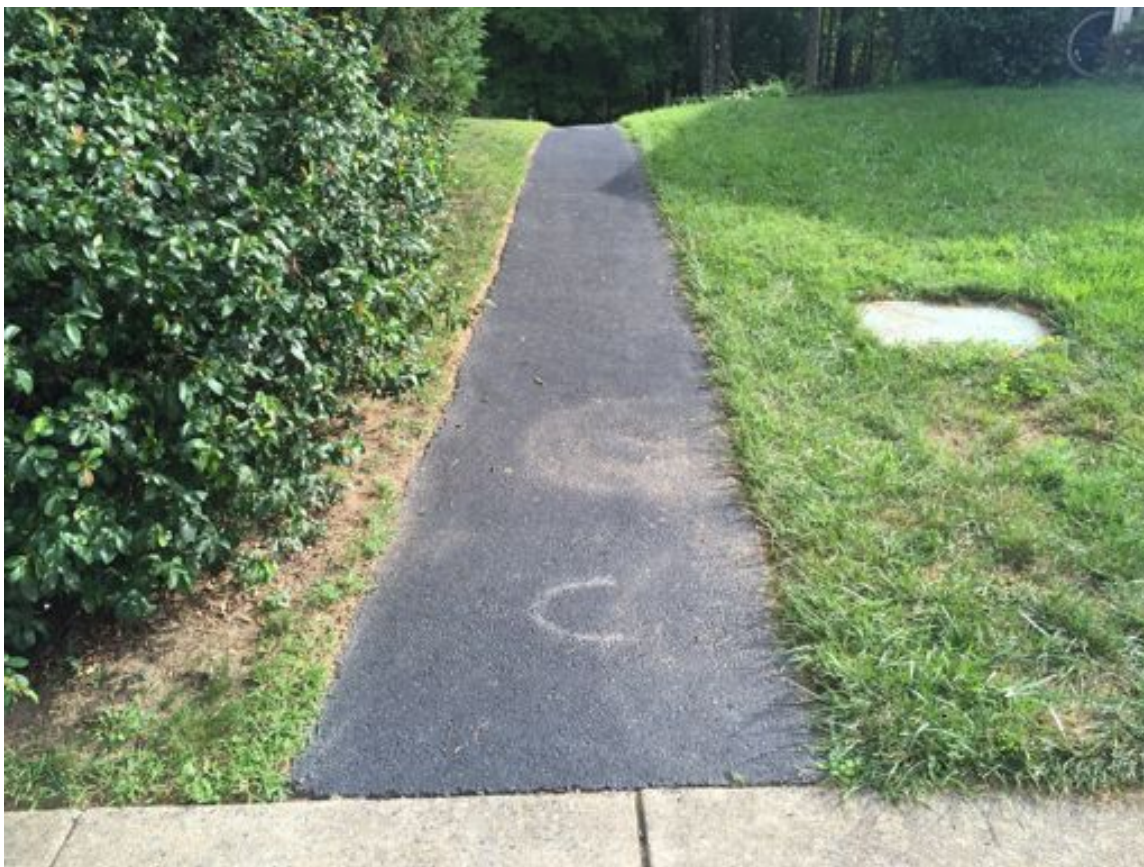
- Component #1, Asphalt Path. This is a 995 foot long, approximately 4 foot wide asphalt walking path that winds through the common area. It begins on Stallworth Court passing through a narrow strip of common area land between lots 70 and 71 (10438 Stallworth Court and 10440 Stallworth Court). The path leads southeast

toward the common area tot lot. Here is a picture of the most westerly starting point of the asphalt path.

In spite of the age of the asphalt path and the limited maintenance it has received over the years, it is deemed in fairly good condition over most of its length. There are some sections that need attention. Weeds are growing through the cracks degrading the path surface in a very few areas. In one location, a fallen tree caused a dent in the asphalt surface that need to be patched.

After the repairs are completed, the path should be cleaned and a hot pour applied to the cracks. After a final cleaning, a seal coat should be applied to the entire path. This maintenance should put the path in good condition again for five years before this type of maintenance will be required again.

Normal maintenance should include cleaning cracks of debris and plant growth. In order to minimize erosion along the edges of the path, it is important to keep the dirt or stones next to the path up to and even with the path surface.

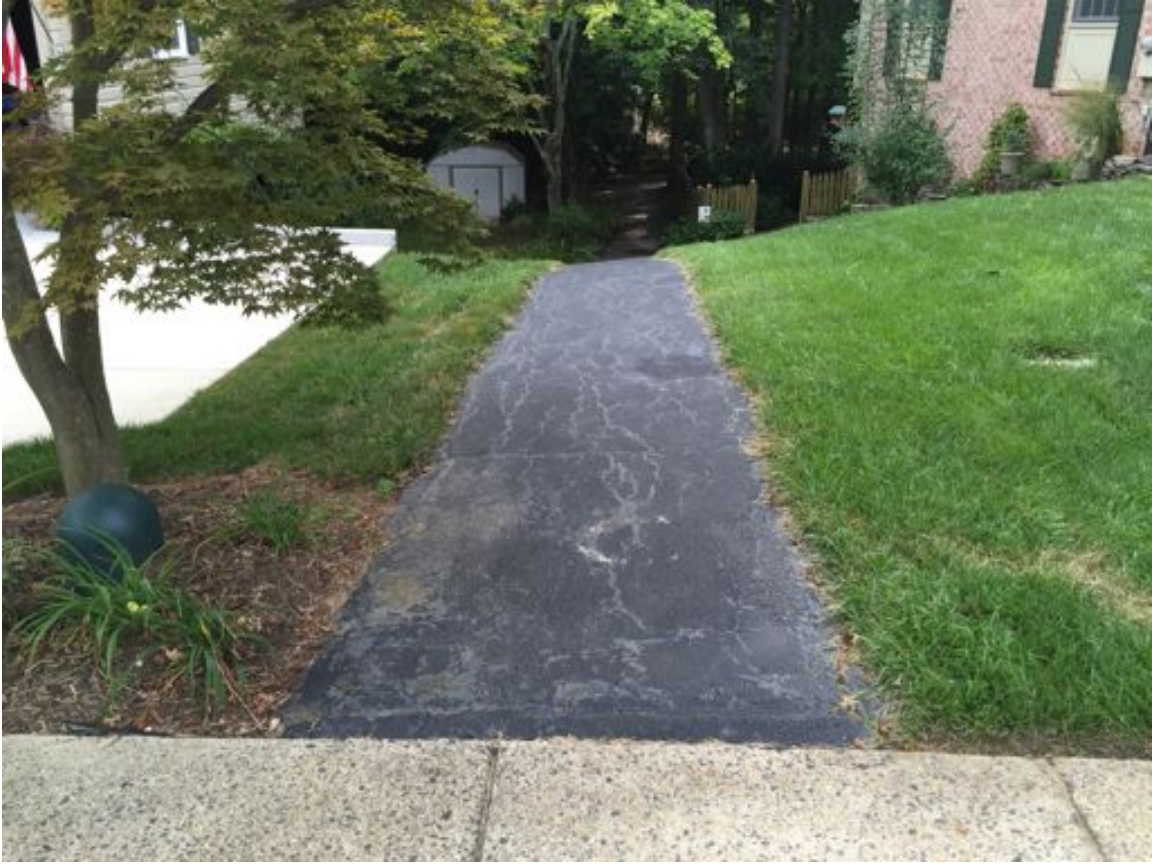
From the tot lot, the asphalt path turns more toward the northeast emerging on Stallworth Court via a narrow strip of common area land between lots 57 and 58 (10412 Stallworth Court and 10414 Stallworth Court). Here is a picture of the most easterly ending point of the asphalt path.

Richmarr Corporation, the developer, built the asphalt path when the homes in Kings Park West, Section 25, were under construction in the 1982-1983 timeframe. Only limited path maintenance was performed over the years. In spite of this, the path has held up remarkably well.

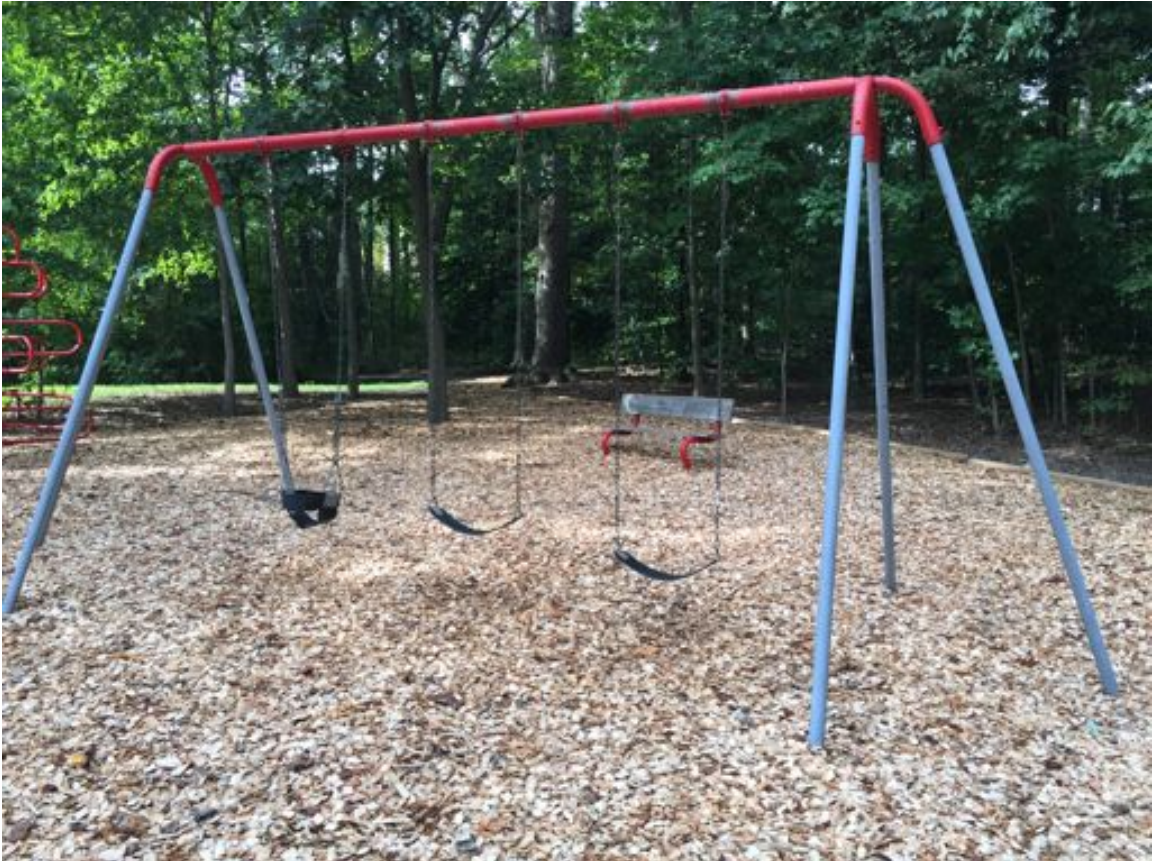
- Component #2, Swing Set. The swing set was installed by the developer, Richmarr Corporation, with the rest of the tot lot equipment in the 1982-1983 timeframe. The swing set is a commercial-grade, metal structure that is 15 feet wide and 9-1/2 feet tall. It includes one child seat and two regular seats. Here is a picture of it.

The swing seats and chains were replaced in 1999 by one of the Association's members using their own tools and funds. Under a Boy Scout eagle scout project, the top of the swing set was scraped and painted red. The inspection team observed that it is getting time to repaint the swing set, preferably in 2017. With normal maintenance and painting every five years, the swing set structure should have an additional lifetime in excess of 35 years.

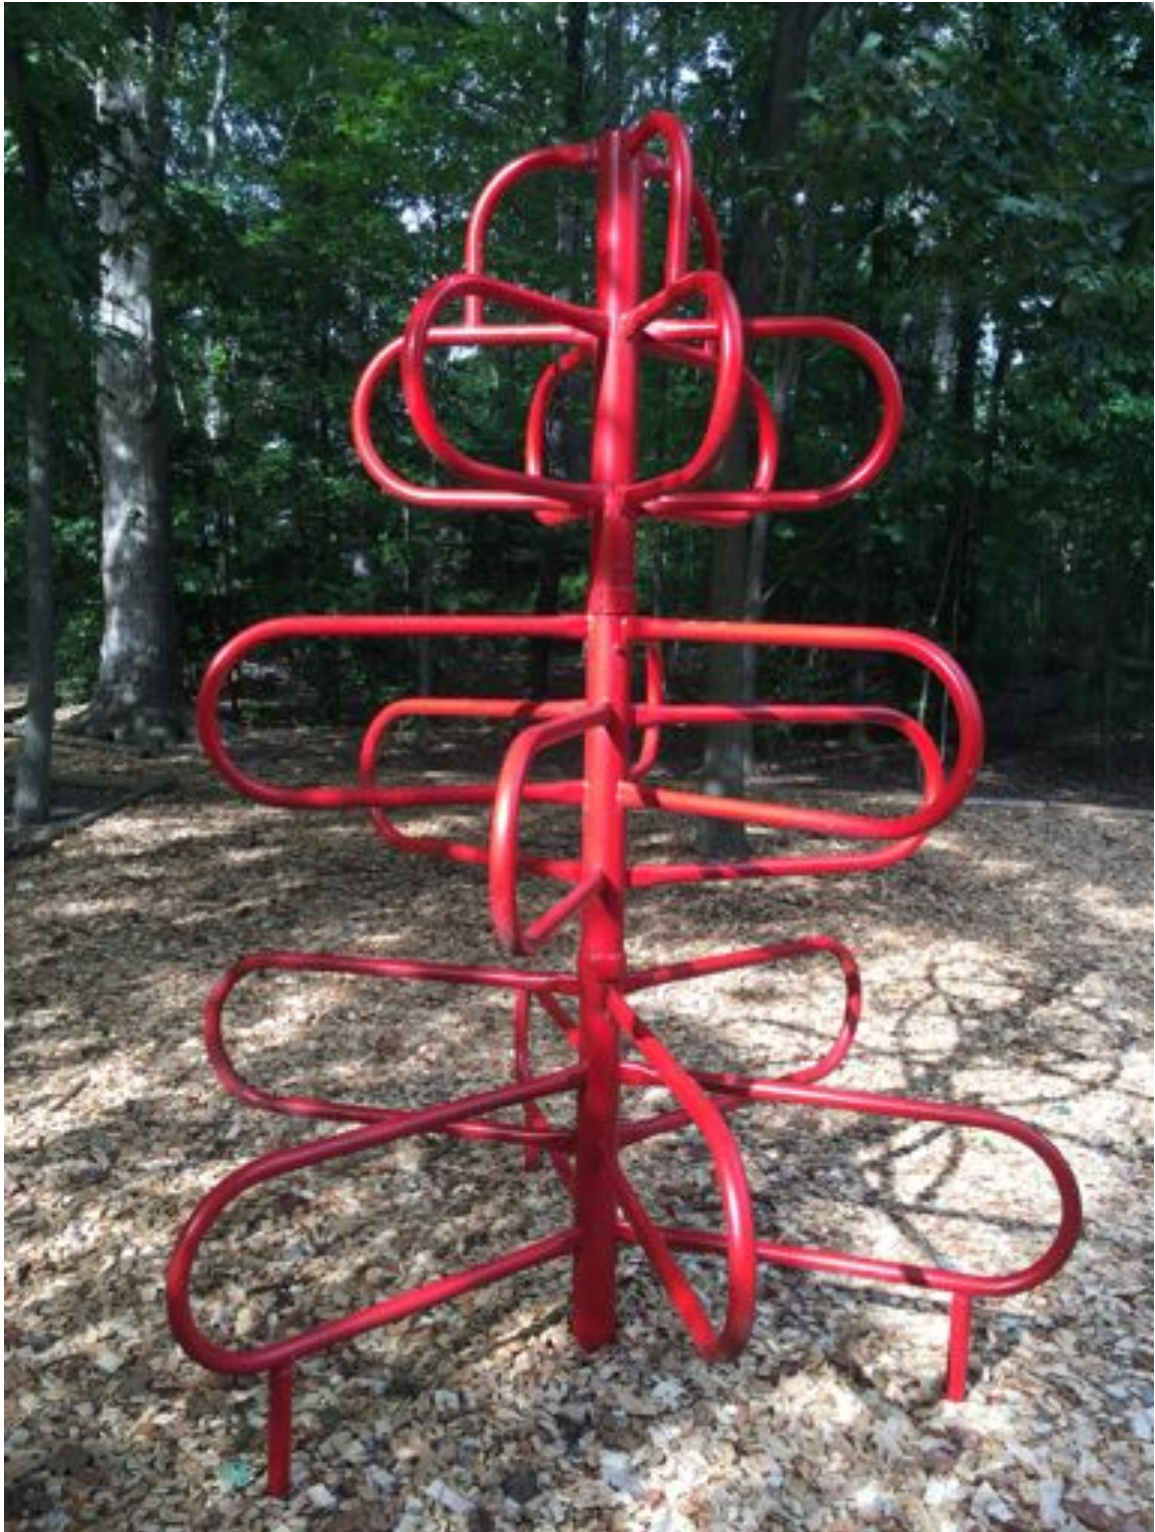
- Component #3, Jungle Gym. The jungle gym was installed by the developer, Richmarr Corporation, with the rest of the tot lot equipment in the 1982-1983 timeframe. It is a very sturdy, professional model that is approximately 7 feet in diameter at the bottom and 9 feet tall as shown in the picture below.

The jungle gym is in good condition, but needs repainting soon, yet it is in better condition than the swing set. The jungle gym was most recently repainted as part of an Boy Scout eagle project in 2012. Repainting in 2017 is recommended. The

jungle gym was observed to be structurally sound during the site inspection. If painting is completed at least every five years, the jungle gym should have an additional lifetime of at least 35 years.

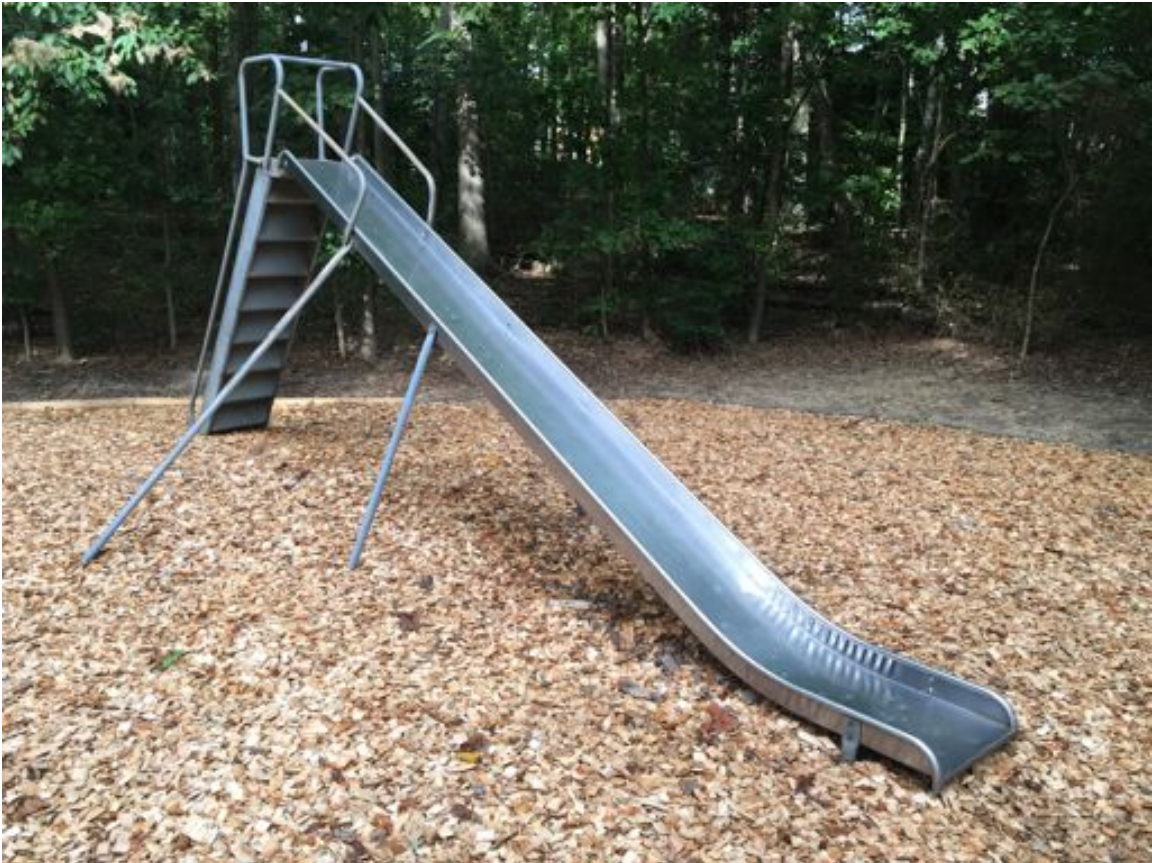
- Component #4, Slide. The slide was installed by the developer, Richmarr Corporation, with the rest of the tot lot equipment in the 1982-1983 timeframe. It is a very sturdy, professional model that rises 8 feet 3 inches high and has a stainless steel slide bed 16 feet long as shown in the picture below.

The slide has received very little maintenance over the nearly 30 years it has been in service. The site inspection found the slide to be structurally sound. There is a little rust on the upper supporting poles and under the top of the ladder, but this is a minor given the age of the slide. Some paint could be applied to cover the rust, but this is not really necessary. The slide should have an additional lifetime of at least 35 years.

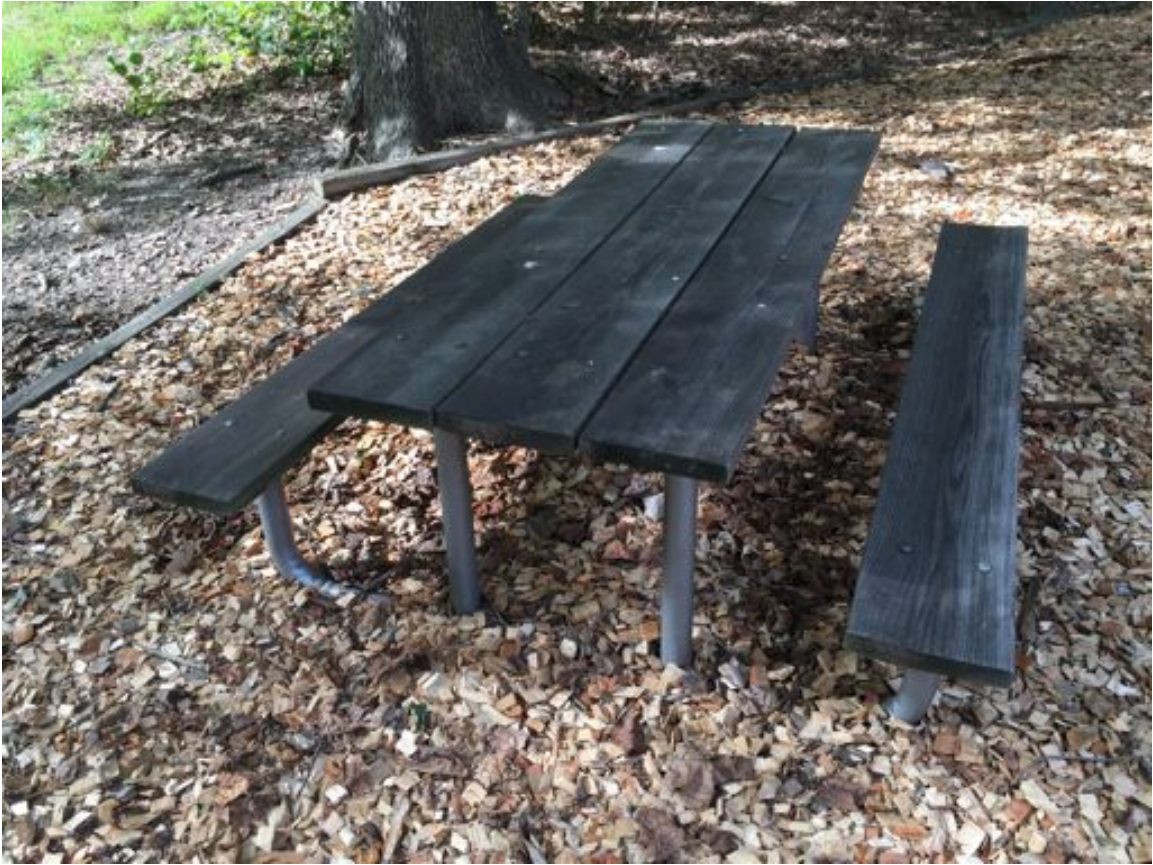
- Component #5, Picnic Table 1. This heavy-duty, 6 foot long picnic table was installed by the developer, Richmarr Corporation, with the rest of the tot lot equipment in the 1982-1983 timeframe. The table is not anchored to the ground. The wood portions of the table were replaced in 2012 as part of a Boy Scout eagle project. The table was found in good condition by the site inspection team. Based on experience of having to perform no maintenance on the table for its first 30

years of service, the table should not need to be replaced for at least another 25 years. The picture of the table is shown below.

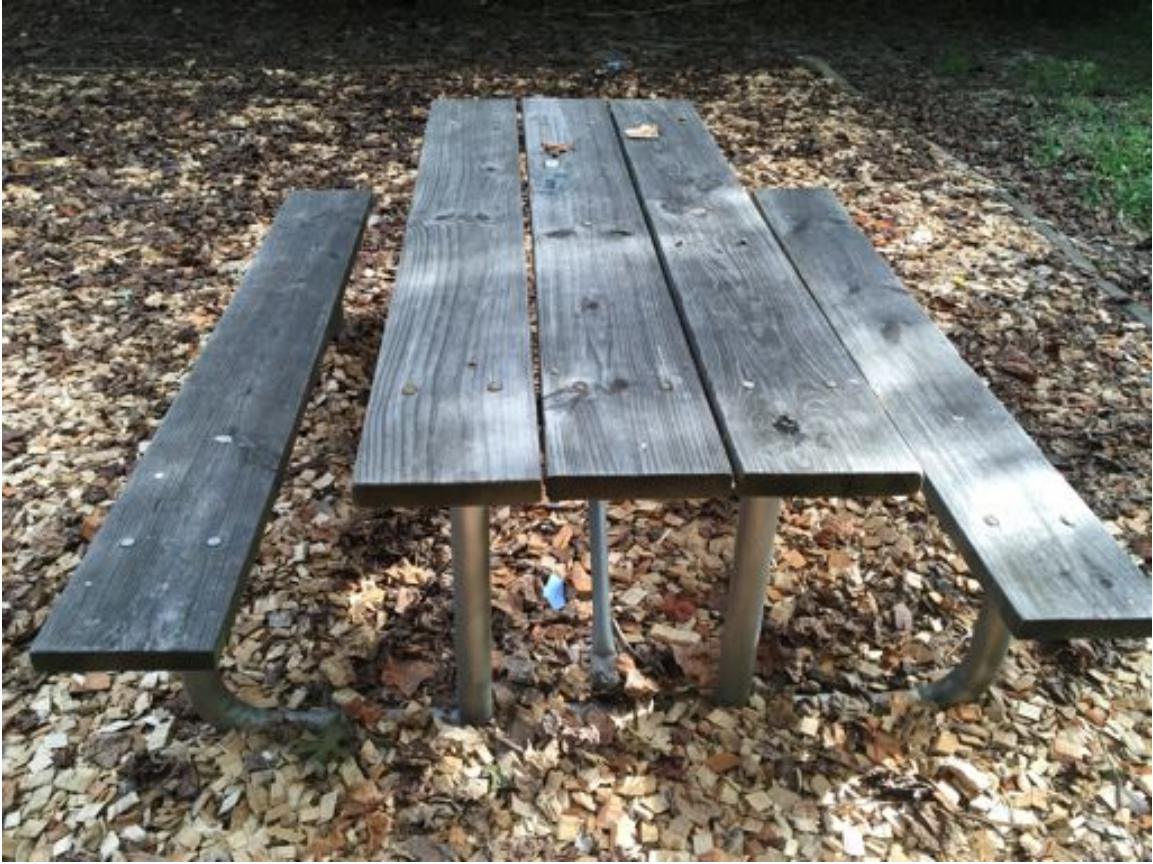
- Component #6, Picnic Table 2. This heavy-duty, 6 foot long picnic table was installed by the developer, Richmarr Corporation, with the rest of the tot lot equipment in the 1982-1983 timeframe. The table is not anchored to the ground. The wood portions of the table were replaced in 2012 as part of a Boy Scout eagle project. The table was found in good condition by the site inspection team. Based on experience of having to perform no maintenance on the table for its first 30 years of service, the table should not need to be replaced for at least another 25 years. The picture of the table is shown below.

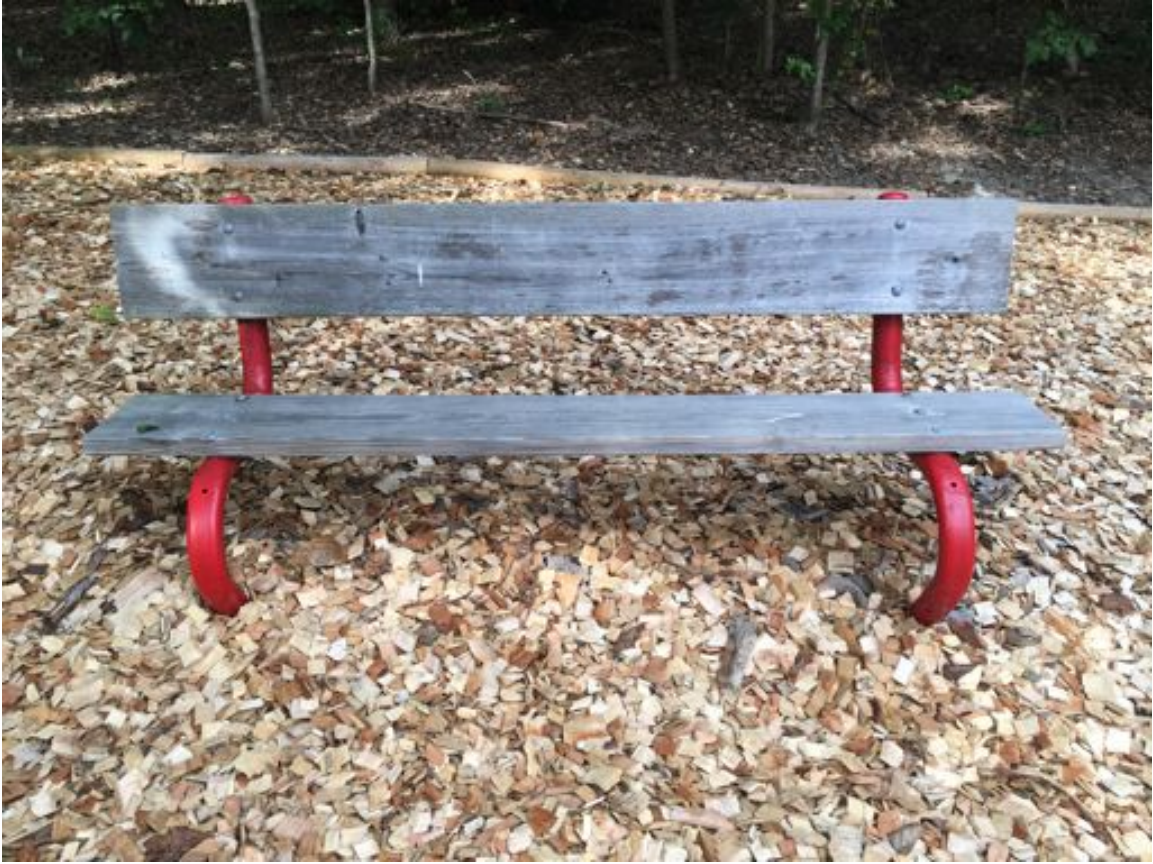
- Component #7, Tot Lot Bench. A heavy-duty, 6 foot long bench was installed by the developer, Richmarr Corporation, with the rest of the tot lot equipment in the 1982-1983 timeframe. The bench is permanently mounted in the ground. It is composed of two metal tubes that support a board on the seat and another board on the back of the bench. The following is a picture of the bench.

The wood on the bench was replaced 2012 as part of a Boy Scout eagle project. The metal parts were painted red as the same time. The site inspection team found the bench in good condition, but recommended that the metal portions be repainted in 2017 and every five years thereafter. The wood portions could last 25 years, the remaining lifetime of the bench.
